REPORT OF INVESTIGATION

Fatal Roof Fall Accident
December 15, 2005

Adkins Branch Mine No. 1A
Arjay Mining, Inc.
Panther, McDowell County, West Virginia
ID No. 46-09106

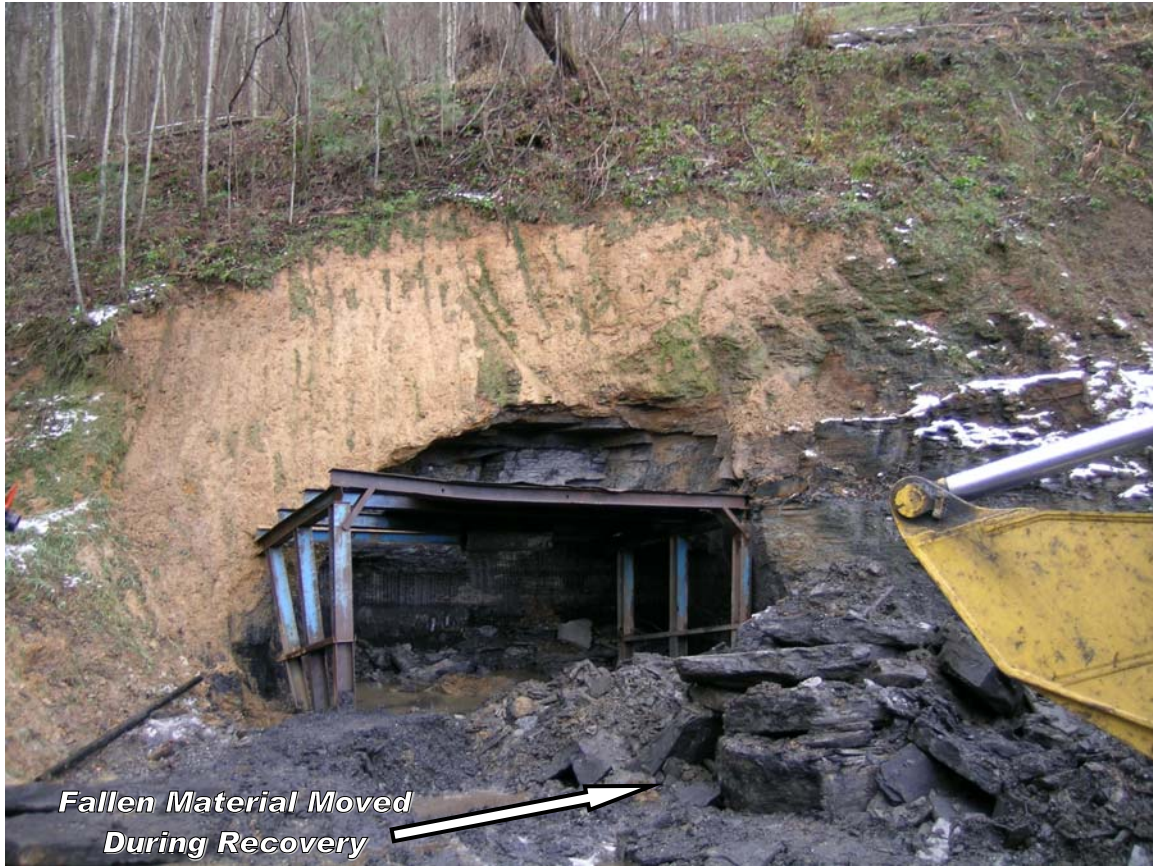
At approximately 12:40 p.m. on Thursday, December 15, 2005, a 35-year old roof bolting machine operator with 11 years mining experience was fatally injured in a roof fall accident. The victim was preparing to install the first row of roof support in the first cut taken from a highwall for a new drift opening when the mine roof collapsed. In an effort to avoid the falling rock, the victim moved in by the machine's automated temporary roof support (ATRS) towards the face, where he was struck by the falling material.

The highwall was not developed in consolidated, competent rock for a height sufficient to insure stability above the mine openings. The ground control plan did not include any methods to be used to control the hazardous highwall conditions or precautions to be taken to keep persons from being exposed to the ground hazards. Hazardous conditions were either not recognized or ignored during numerous workplace examinations. The accident resulted from failure to follow proper mining practices, procedures, and the applicable regulations. The lack of effective administrative controls contributed to the accident.

Mining conducted in the number one entry by Arjay Mining exposed weathered incompetent roof rock which fell during the initial installation of permanent roof supports in the mine entry. Additionally, the provided canopy installation was not sufficient to prevent injury to persons from the falling roof material. Hazardous conditions were either not recognized or ignored during numerous workplace examinations. The accident resulted from failure to follow proper mining practices, procedures, and applicable regulations. The lack of effective administrative controls contributed to the accident.
